Application Note 1034: MXZ Branch Box Applications with Blue Diamond Pump

Author **Matthew Goltz** | Technical Services Department

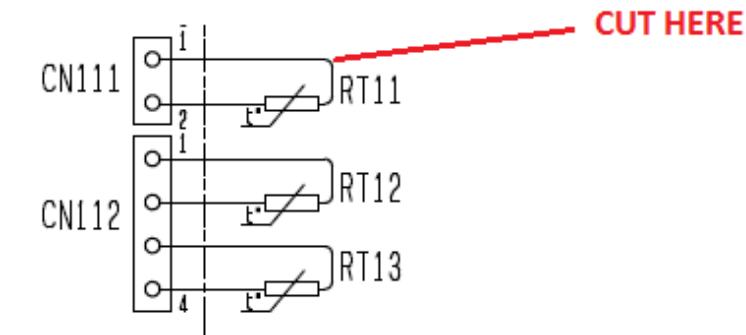
Blue Diamond pumps use a heated thermistor to monitor for high water level. In order for the NC (normally closed) safety contacts to close the thermistor needs to heat up. It can take up to 2 minutes to heat to the proper temperature and then close the contacts.

Wire the NC safety circuit from the pump in series with one of the indoor thermistors. Best practice is to solder the connection, or use butt splice connector.

****FOR APPLICATIONS USING THE APPLICABLE MODELS, DO NOT BREAK THE S1, S2 or S3 WIRE TO THE INDOOR UNIT OR ERROR WILL OCCUR****
